Stress analysis of an optimized high pressure die casting tooling insert

# HIGH PRESSURE DIE CASTING

## The Importance of Design for AM

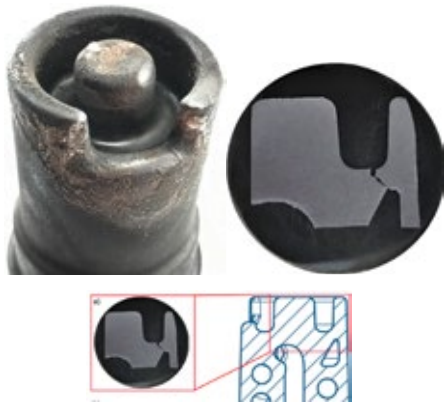
## Case 2: Part fail because of soldering and cracks which leads to a leakage in cooling system

less soldering and stresses

The original design didn't minimize the stress level. Therefore the crack started from the area in the cooling channel with high stresses. Via redesign of the channels the stress could be significantly be reduced and the cooling even improved.

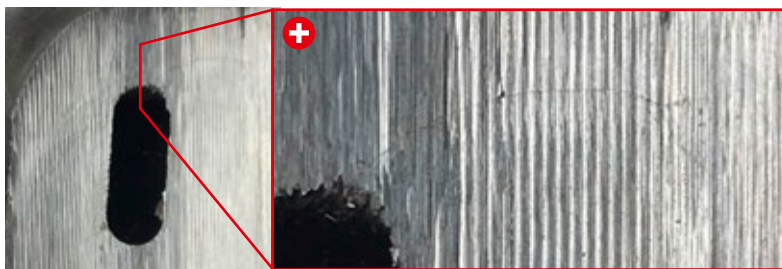
## Case 3: Part failed because of cracks

Cracks initiated from the cooling channels lead to leakage and to part failure. Stress analysis showed the highest thermo-mechanical stresses exactly in the area where the crack started.

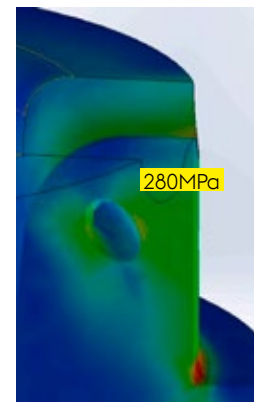
### Optimized

Adjusted redesign to reduce the maximum stress by 20% while keeping the cycle time and cooling rate
